# Special coatings for severe service: experimental approach by DAFRAM test bench

Eng. Marco Sparisci  
Lead Product Engineer

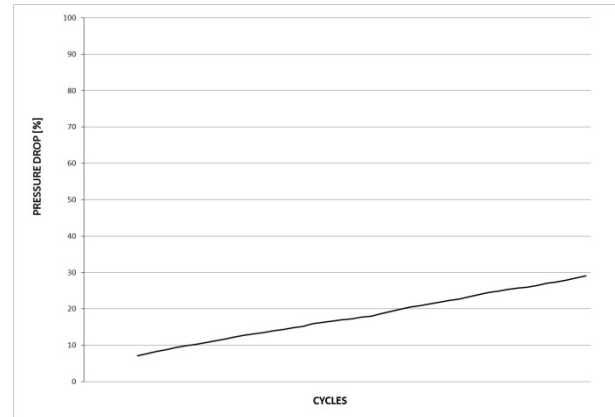
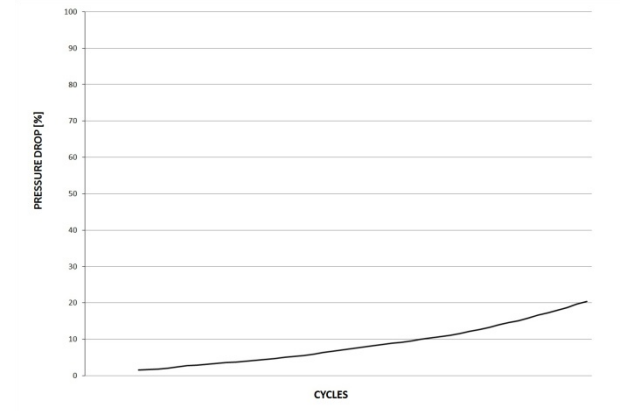
- Leakage monitored (in terms of pressure drop) every 50 cycles
- Room temperature
- 1000 cycles

- Coating A: moderate leakage, maximum torques 626 Nm (at room temperature) and 670 Nm (at high temperature)
- Coating B: leakage starting from first cycle (room temperature), remarkable leakage at high temperature (no galling), maximum torques 568 Nm (at room temperature) 638 Nm (at high temperature)
- Coating C: moderate leakage, maximum torque at room temperature 690 Nm, galling occurred during high temperature test for one of the specimens: test failed

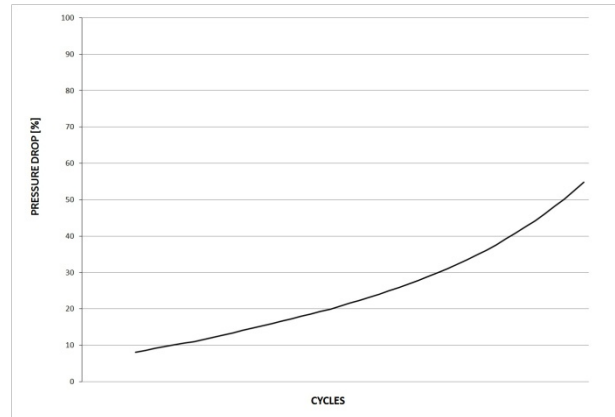
- Leakage monitored (in terms of pressure drop) every 50 cycles
- Test temperature: 250°C
- 1000 cycles

Average value of the  
two undamaged  
specimens
